QUALITY OF SIDEWALKS IN A BRAZILIAN CITY: A BROAD VISION

Keywords: Sidewalk quality index; pedestrians; urban planning; cities.

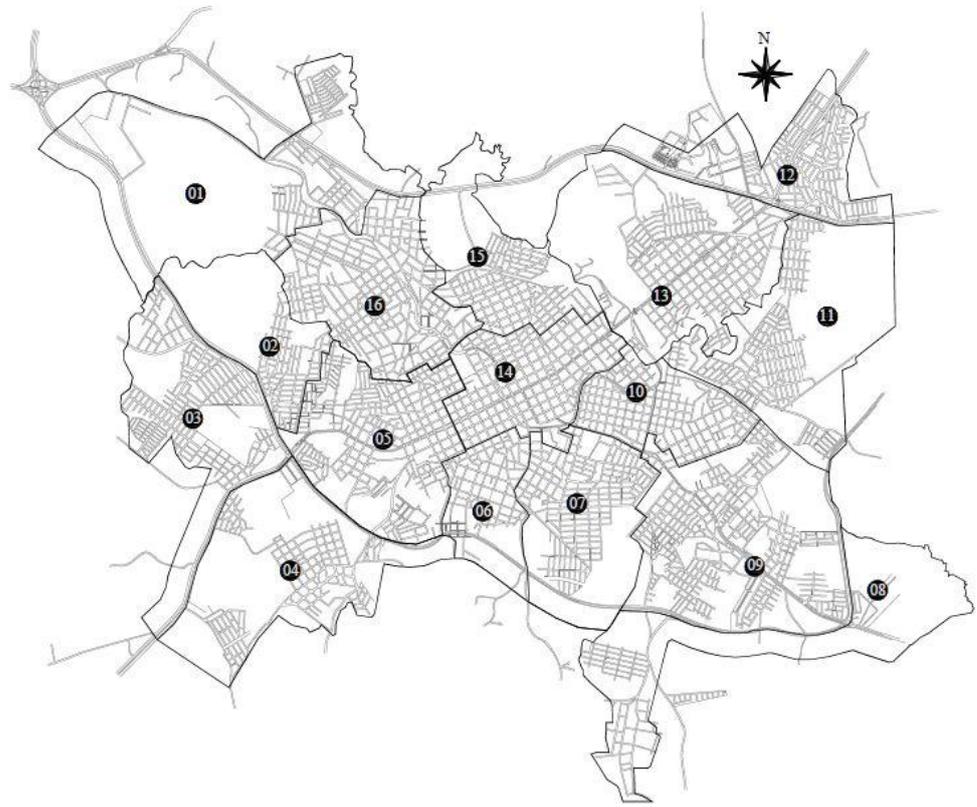
FIGURE 2 - STUDIED SECTORS IN THE URBAN AREA OF PASSO FUNDO

Figure 2 shows the 16 sectors under study (in each one, a block was randomly selected for analysis); and Figure 3 illustrates the three methodological steps for assessing the quality of sidewalks.
