AN ANALYSIS OF A LOW-INCOME HOUSING REGARDING FUNCTIONALITY AND ACCESSIBILITY REQUIREMENTS AND POST-OCCUPANCY EVALUATION

Keywords: Low-income Housing. Social Housing Post-Occupancy Evaluation. Building Performance. Satisfaction.

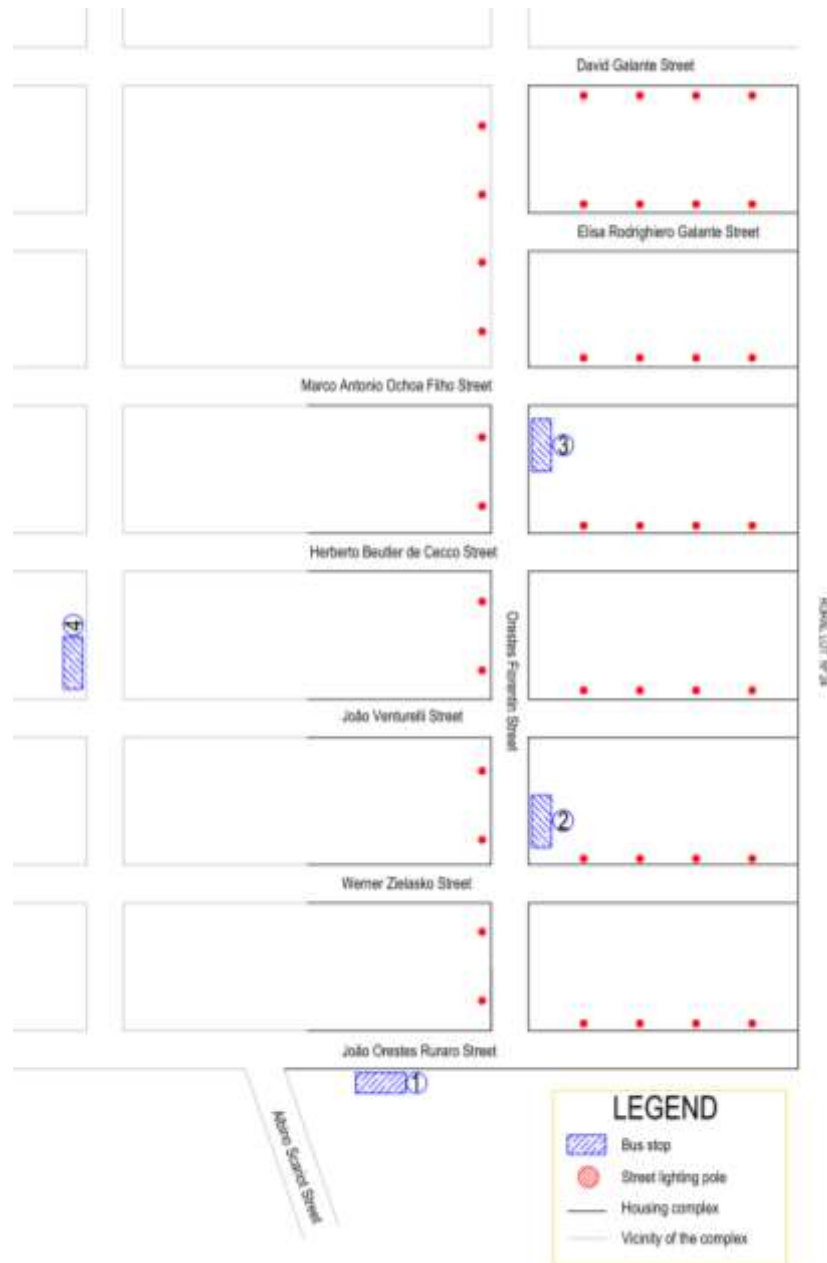
FIGURE 4 - DIAGRAM INDICATING THE BUS STOPS AND LIGHT POLES PRESENT IN THE VICINITY OF THE JARDIM DAS ORQUÍDEAS SUBDIVISION
Source: Authors (2022).

(grocery stores) of residents in the set (items 1, 2, 3, and 4); however, through the interviews, it is possible to perceive that in the case of purchases of food and hygiene materials, many residents prefer, due to the better value for money, go to the larger supermarkets, which are located approximately 2.5 km from the Jardim das Orquídeas allotment. Thus, as indicated in Figure 3, this group fit in “Regular” statistically. There are only two places for entertainment: a playground (item 5) and a multi-purpose arena (item 6).

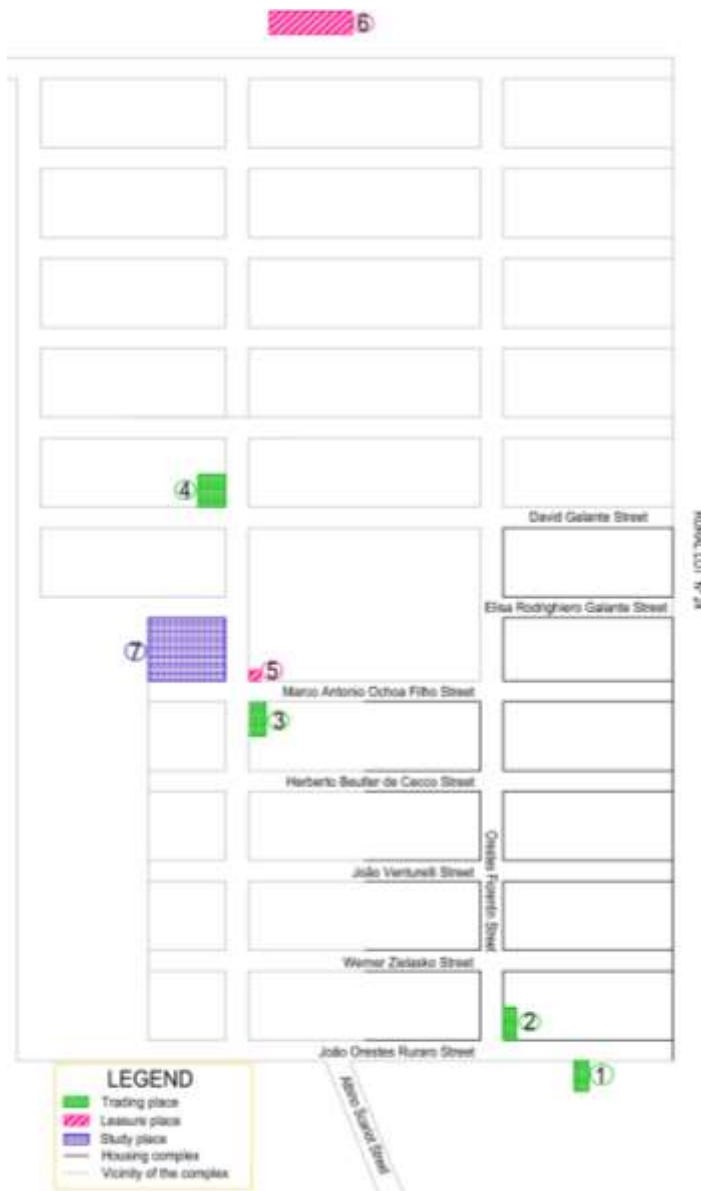
FIGURE 5 - COMMERCE, SQUARES, AND CMEI CLOSE TO THE HOUSING COMPLEX

Other components observed are in Figure 5.

Implementing the multi-purpose arena, composed of a skate park, synthetic soccer field, and multi-sport court, was an initiative of the city hall in January 2019, which aims to encourage the practice of sports and increase the quality of people's health (TOLEDO, 2019). There are neither in the playground nor in the multipurpose arena devices for PWD use. Despite the presence of these two spaces for leisure, the residents are unhappy with the areas provided, being the only group in the complex's surroundings to be classified as "Bad". Based on the comments made by residents, this note is attributed to the fact that there are no places for leisure aimed at the adult population near the complex and the lack of security that residents feel in these places. Leisure places such as squares and playgrounds are also marked in Figure
